### Log of Boring RISB-02

Final Remedial Investigation Report  
Casmalia Resources Superfund Site  
Casmalia, California

# E9-54

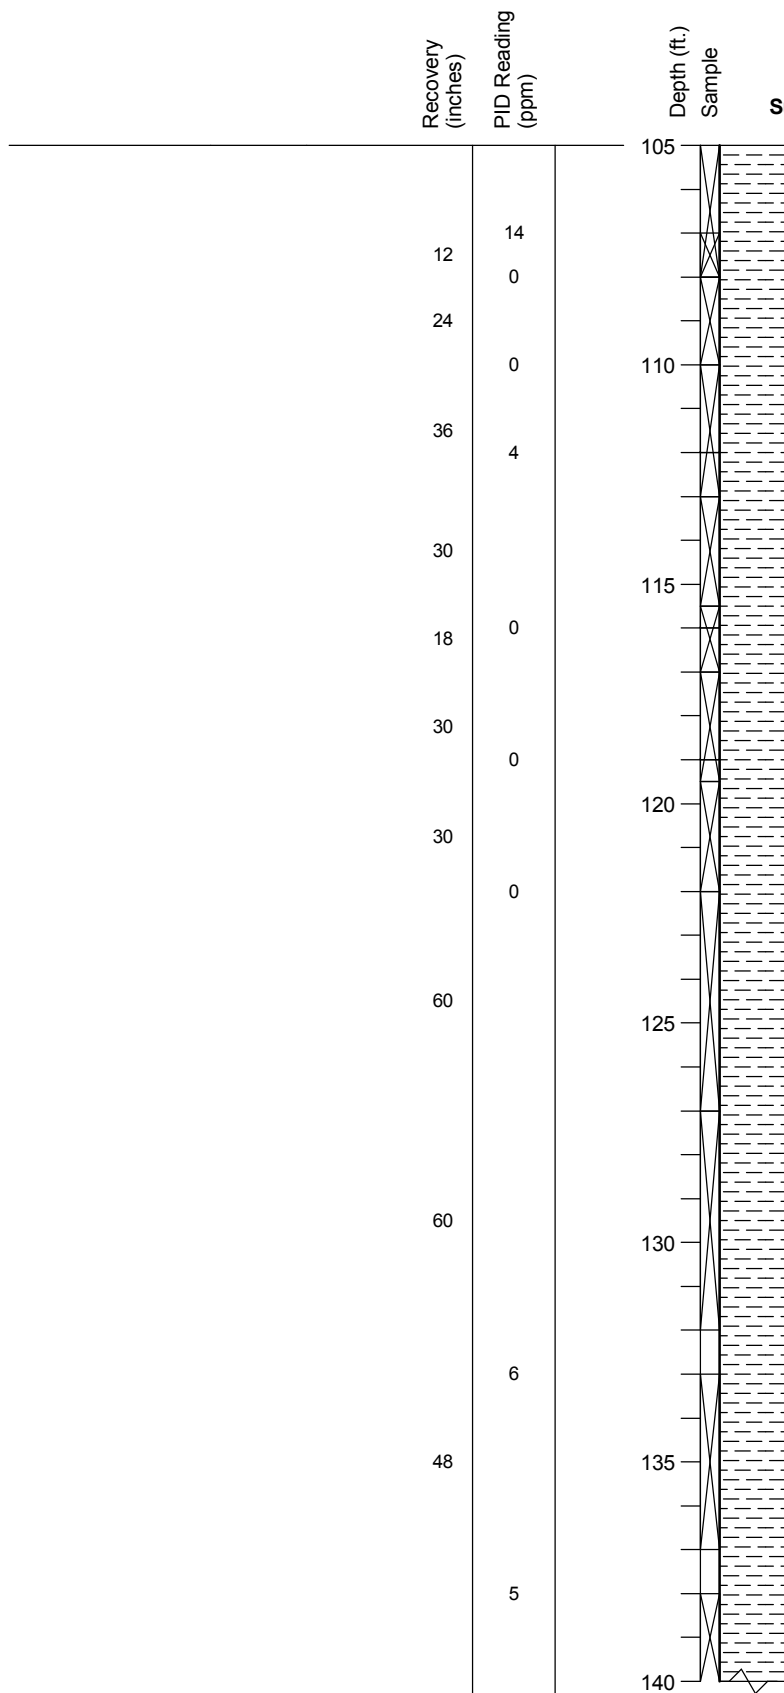
@109 ft.: Fracture observed in video log, fractures observed in optical televiewer at 108 and 109 ft.

@114 ft.: Fractures with dendritic pattern observed in video log

@116-118 ft.: Vertical fracture observed in video log

@122-128 ft.: Possible fractures or mechanical breakage of core, vertical fracture along western side of borehole observed in optical televiewer

@130 ft.: Vertical fracture observed in southern side of borehole in optical televiewer  
 @130.8-131.5 ft.: Vertical fracture

@132 ft.: Brown residue coating fracture, vertical fracture observed in video log

@135 ft.: Continue as above, little fracturing, moderately strong, moderately hard, little weathering

@137 ft.: White layering no longer present

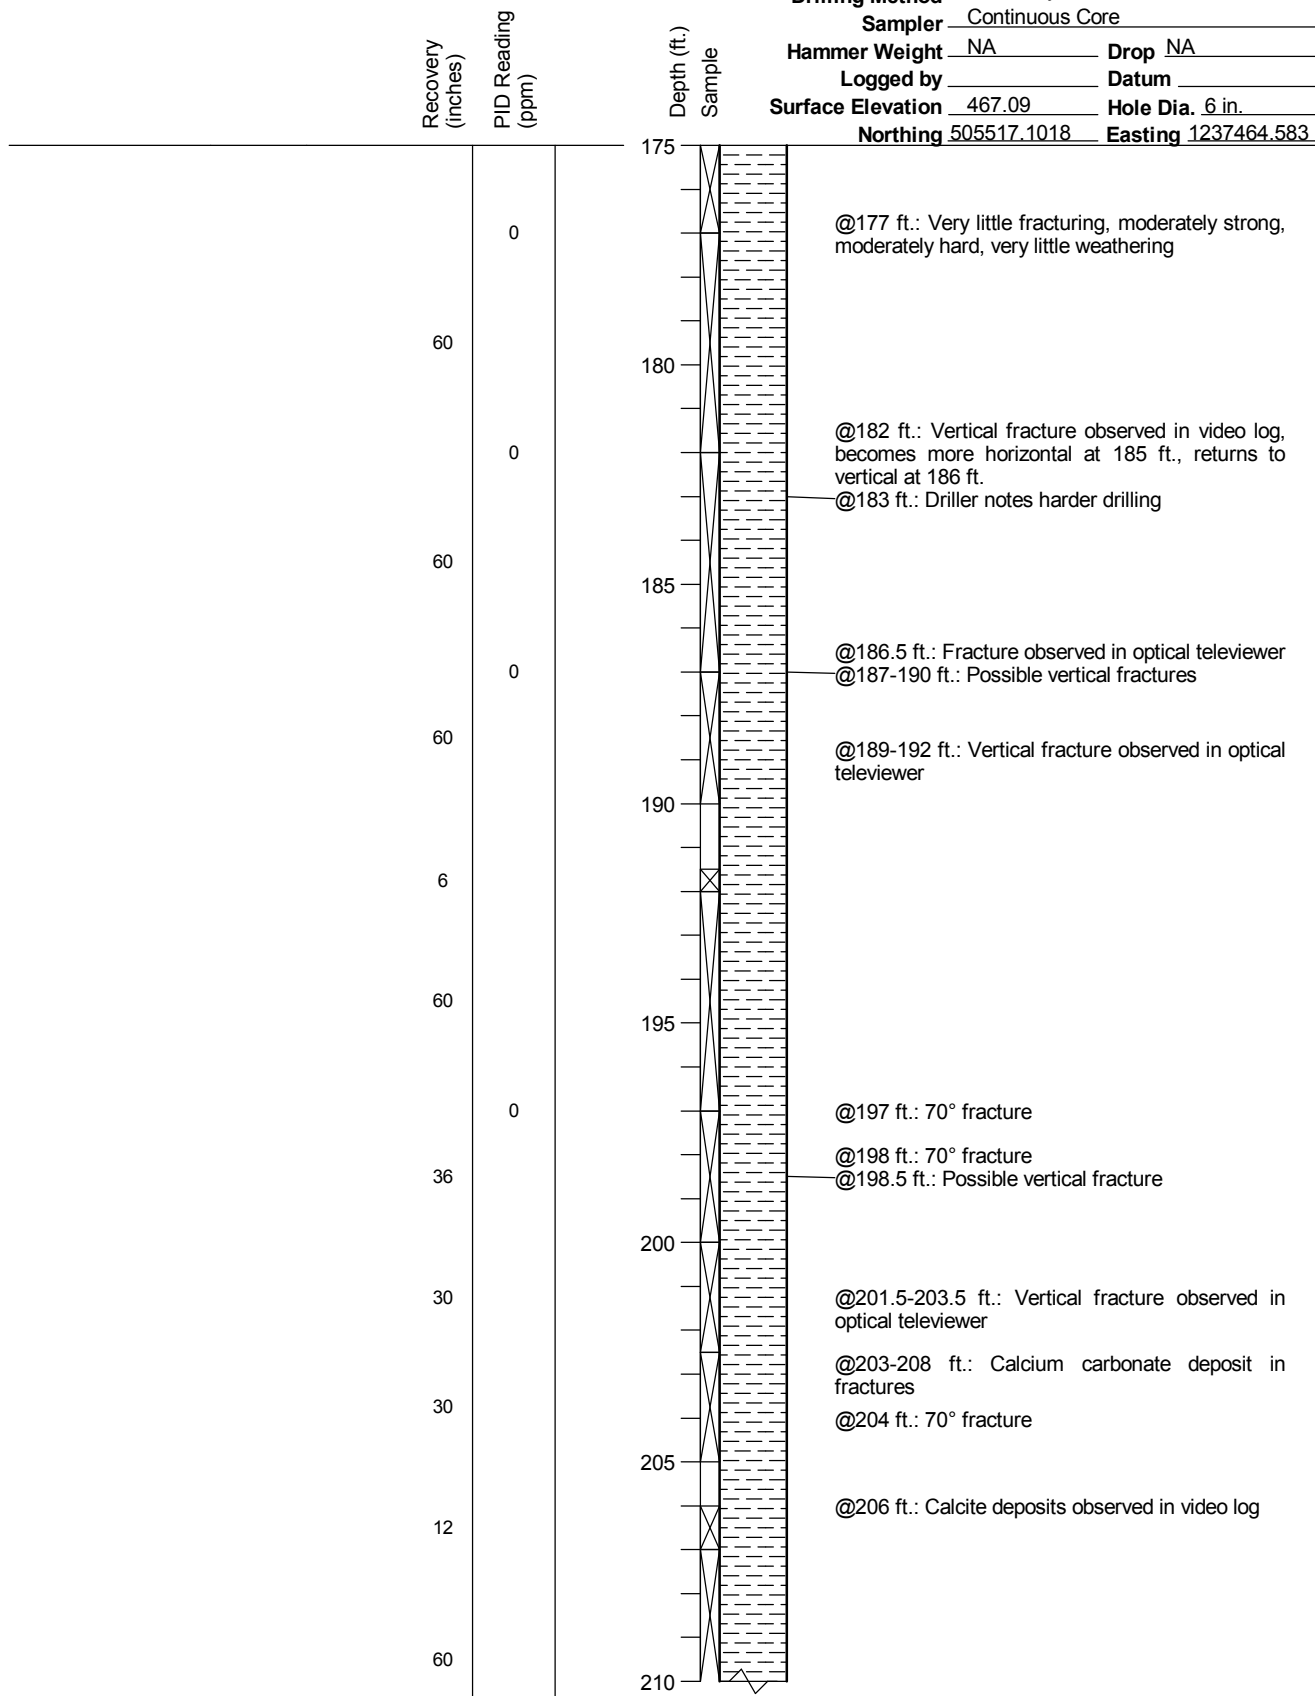
### Log of Boring RISB-02

Date 9/26/06  
 Driller Air Rotary  
 Drilling Method Air Rotary  
 Sampler Continuous Core  
 Hammer Weight NA Drop NA  
 Logged by \_\_\_\_\_ Datum \_\_\_\_\_  
 Surface Elevation 467.09 Hole Dia. 6 in.  
 Northing 505517.1018 Easting 1237464.583

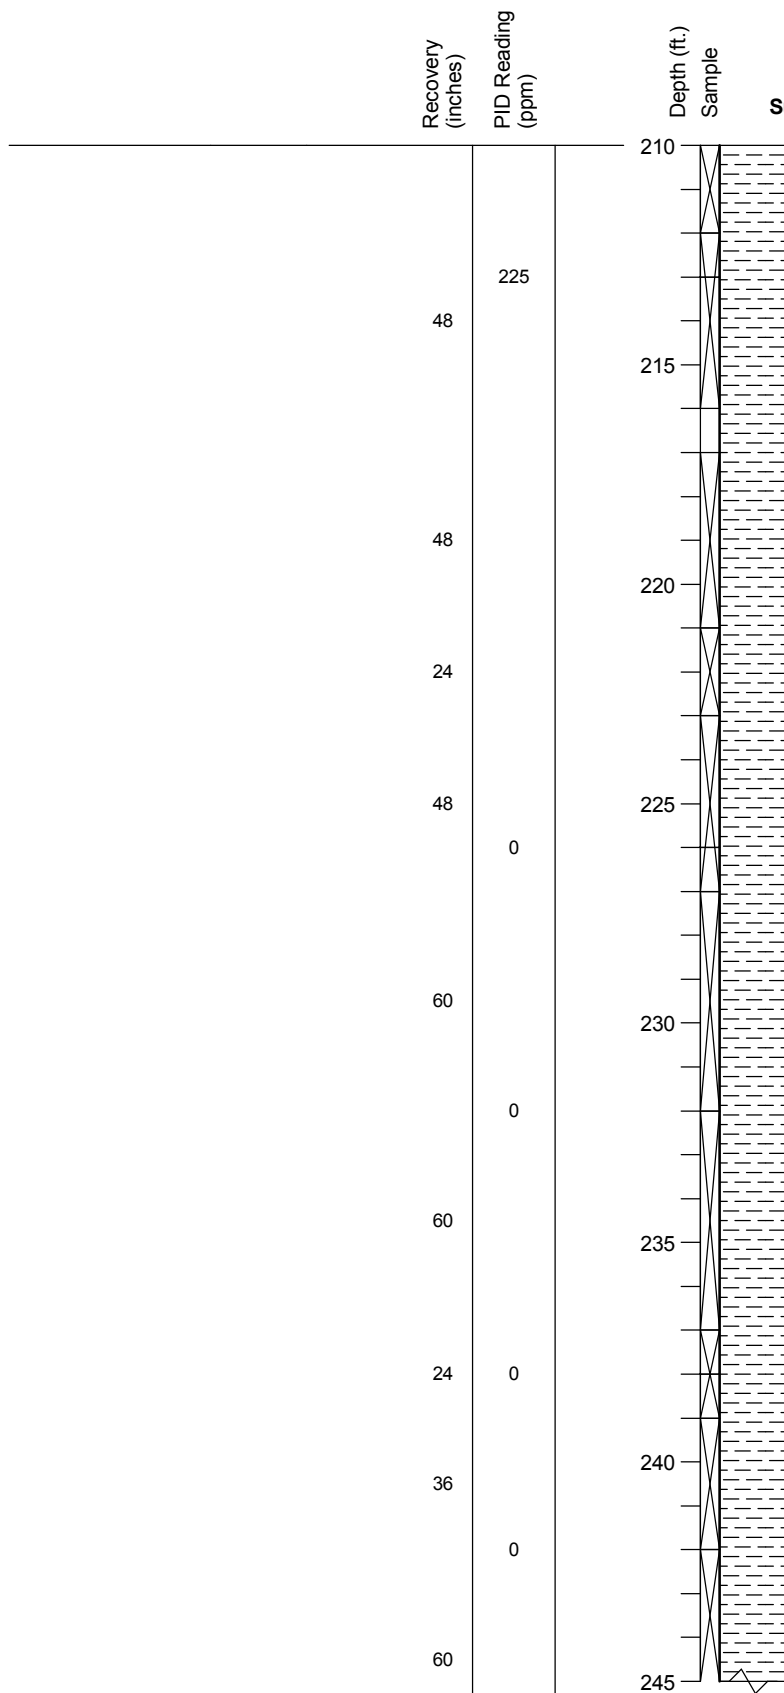
@211-214 ft.: Possible fracture zone

@217 ft.: Fracture observed in optical televiewer

@222.5-224 ft.: Multiple hairline 70° fractures observed in optical televiewer

@224 ft.: Very little fracturing, moderately hard, moderately strong, little weathering

@225-227 ft.: 70° fracture observed in optical televiewer

@235.5-236.2 ft.: 70° fracture
